# Navajo Abandoned Uranium Mine Site Screen Report

## **Haystack No. 2 AUM Site**

## **Navajo AUM Eastern Region**

**May 2009**

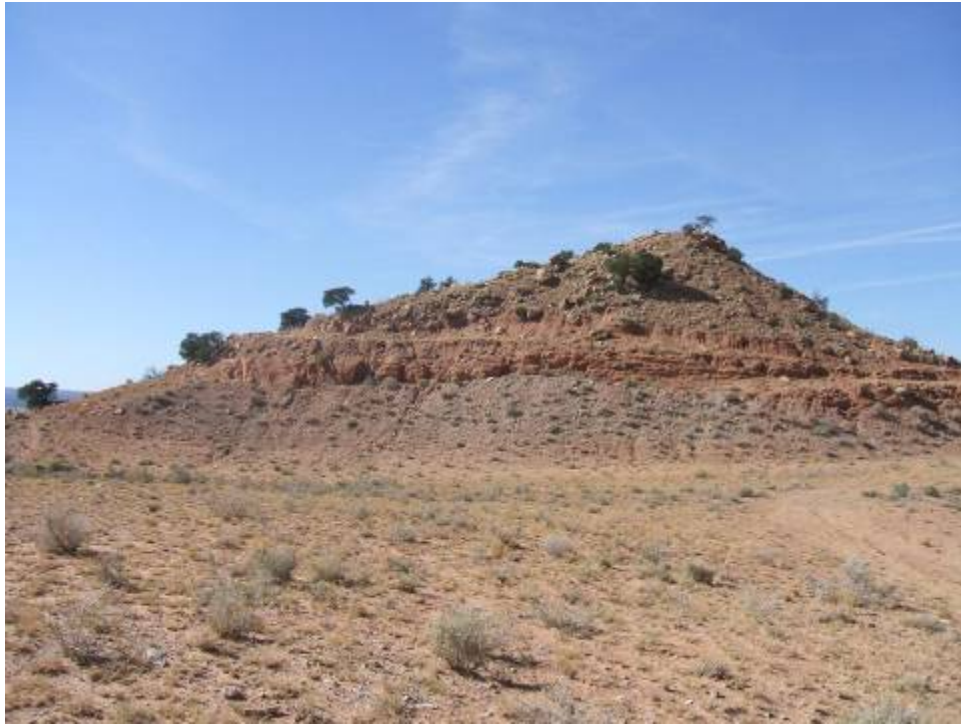
Photo 1. Haystack No 2 mine site, towards the west

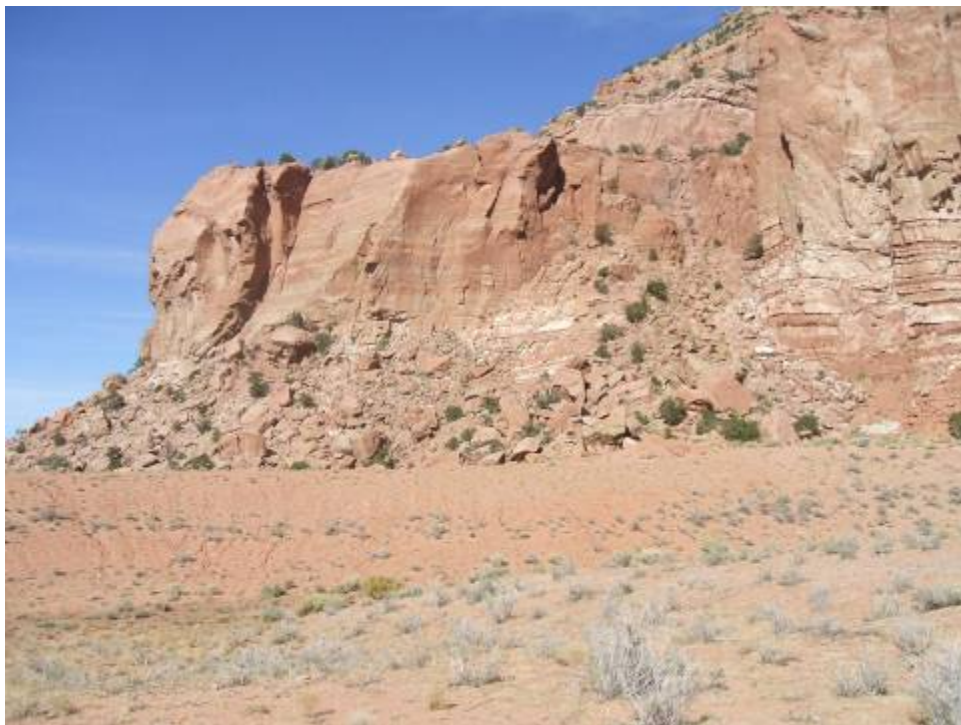
Reclamation status of the mine sites are currently unknown. No visible signs of reclamation were observed. A large recessed area in the center of the site may have been used as an open pit (Photo 2). No waste piles, adits, or other mine features were observed during the site visit.

Photo 2. Haystack No 2 mine site and open recessed area, towards the north

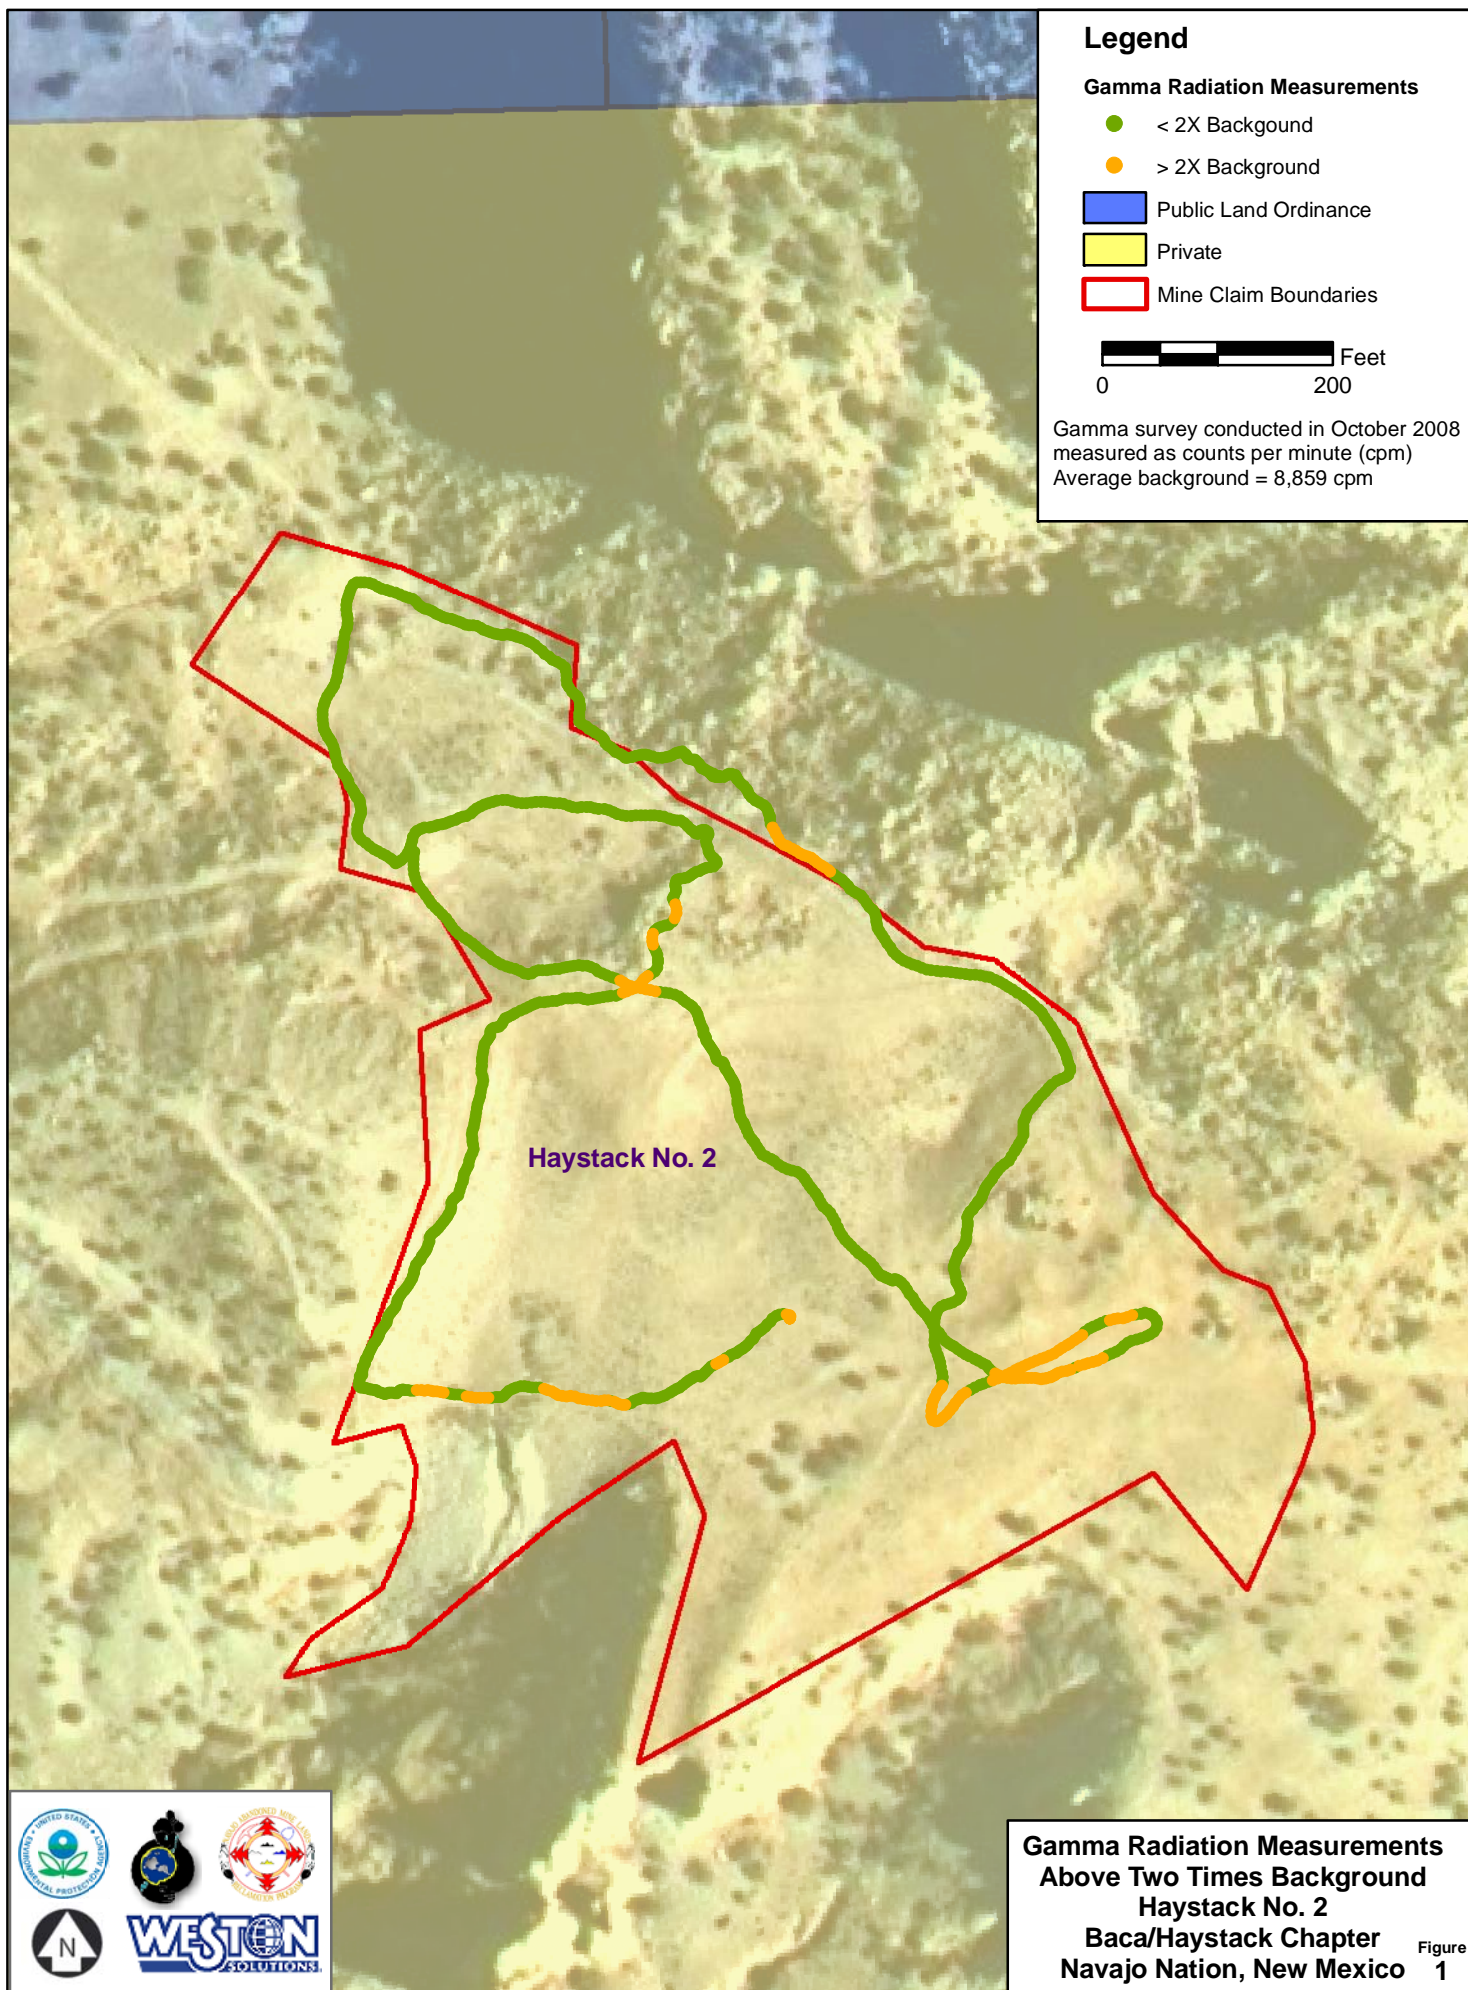
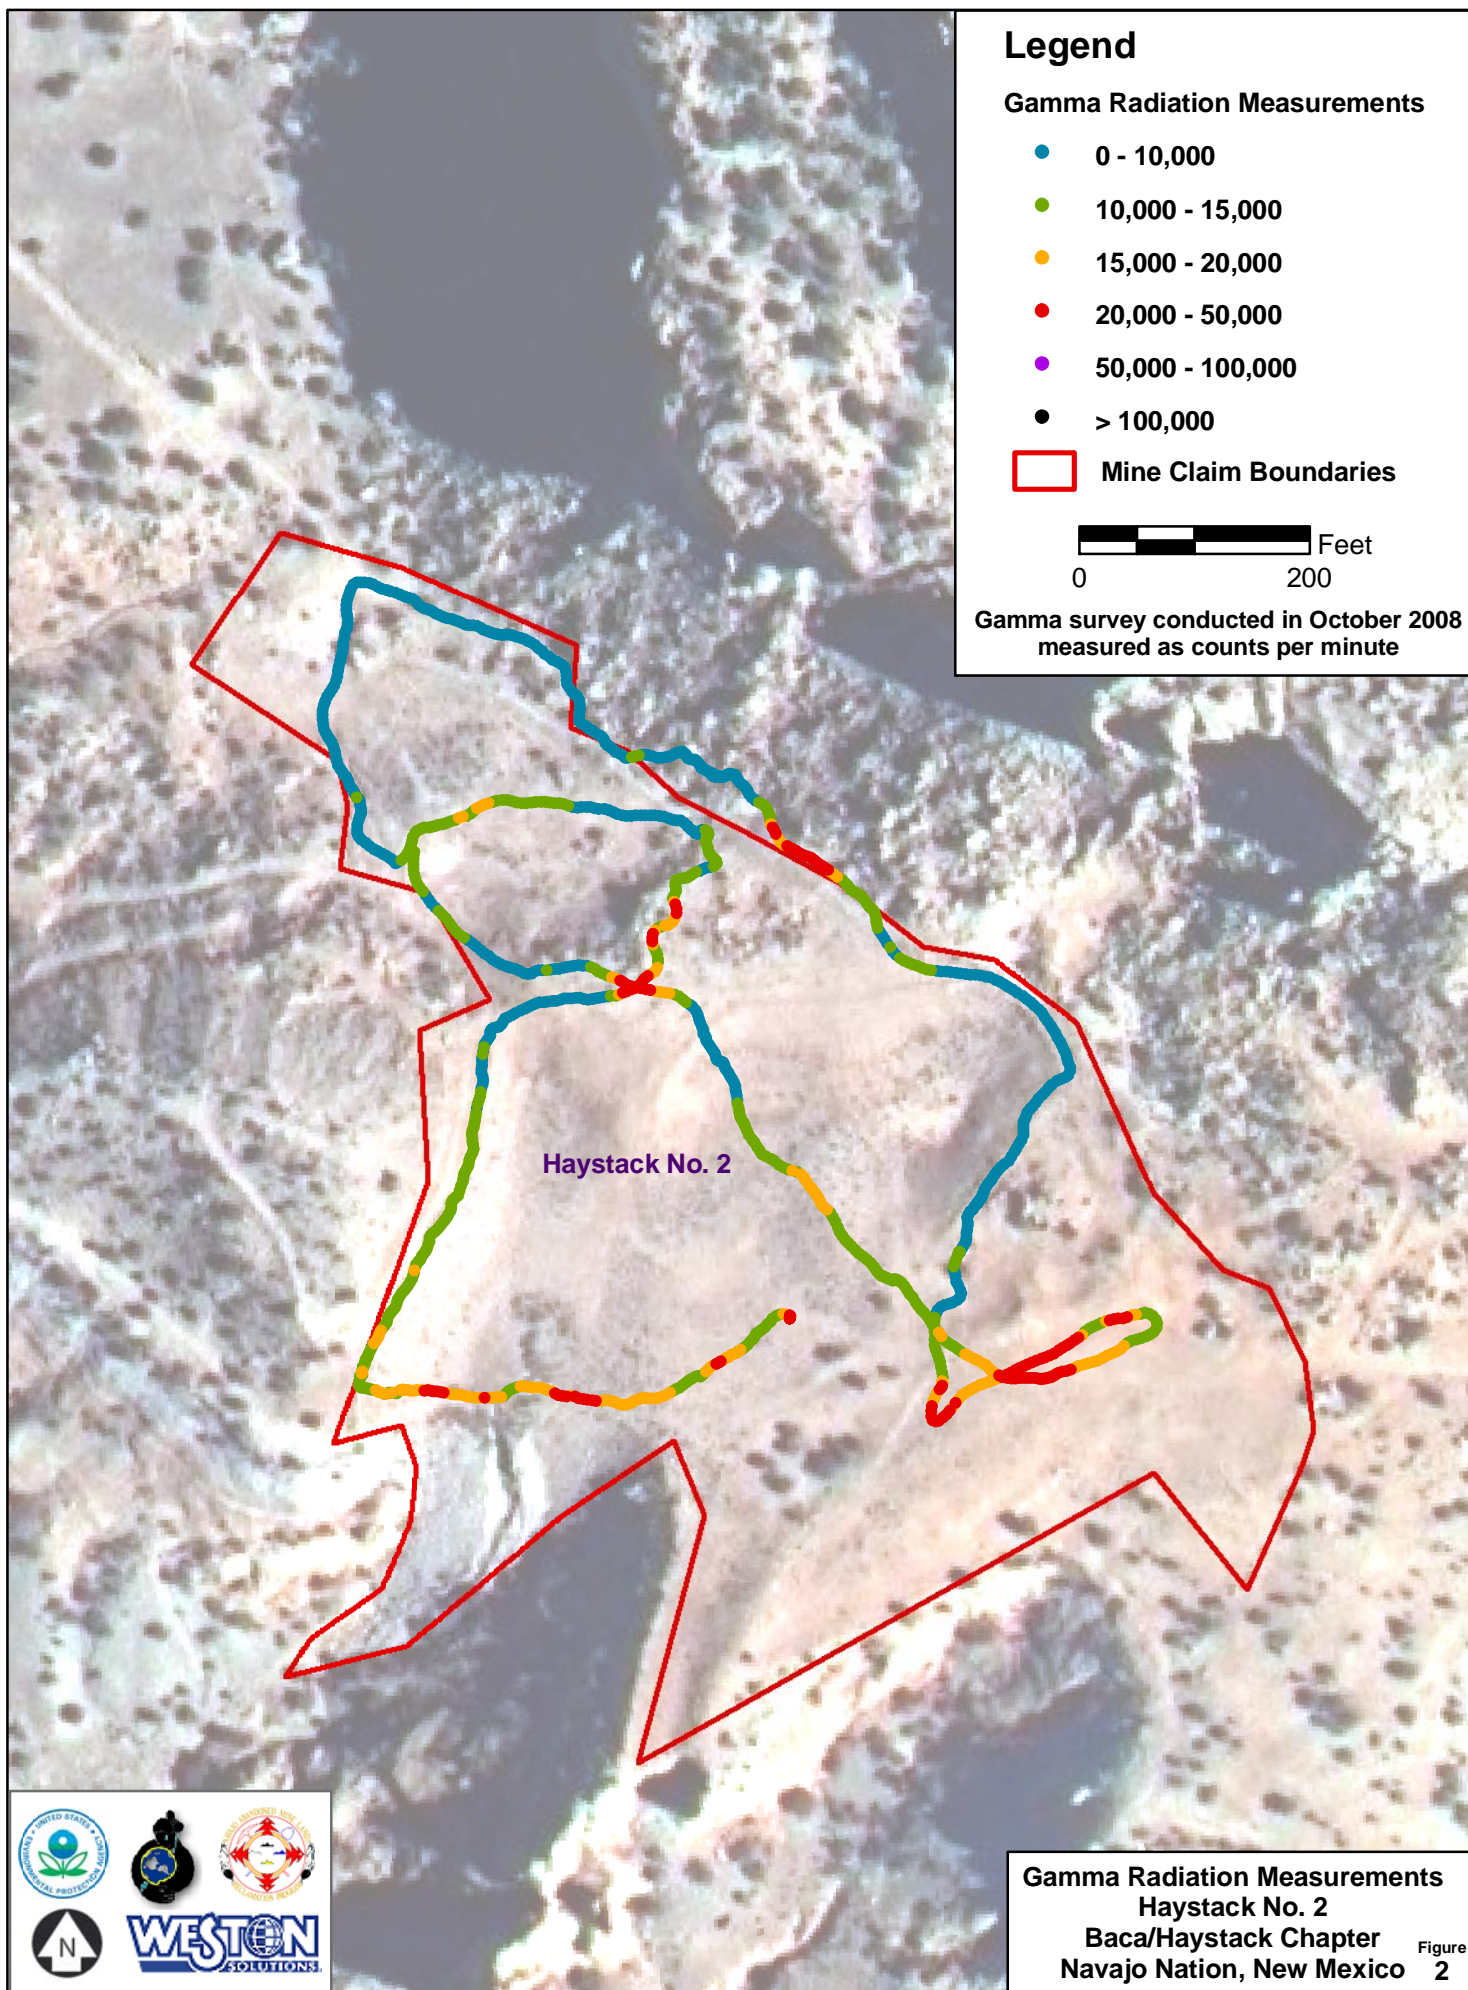
**Mine site:** Haystack No. 2  
- See Figures 1 and 2

A total of 1,210 gamma radiation measurements were collected from the mine site, ranging from 6,155 cpm to 32,732 cpm. The measurements are represented in Figures 1 and 2. Radiological measurements collected for the New Mexico Mining and Minerals Division during a 2008 field screening survey found gamma radiation levels near the ground surface with a maximum of 90 micro Roentgen per hour ( $\mu\text{R/hr}$ ) and a minimum of 10  $\mu\text{R/hr}$ , levels at the 4-foot elevation with a maximum of 60  $\mu\text{R/hr}$  and a minimum of 9  $\mu\text{R/hr}$ , and background levels of 10  $\mu\text{R/hr}$ .
